A Summary of a NIOSH fire fighter fatality investigation

## Volunteer Fire Fighter Dies After Tanker Truck Is Struck by Freight Train - Kentucky

## Fatality Assessment and Control Evaluation Investigative Report #F2002-10

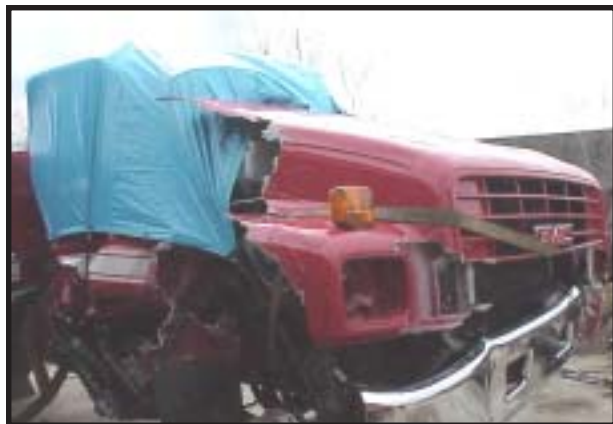
Vehicle involved in incident

**Equipment.** The 1,500-gallon (2001) tanker truck involved in the incident was approximately 23 feet, 5 inches long with a gross vehicle weight<sup>a</sup> of about 10,000 pounds; the tank was full of water at the time of the incident.

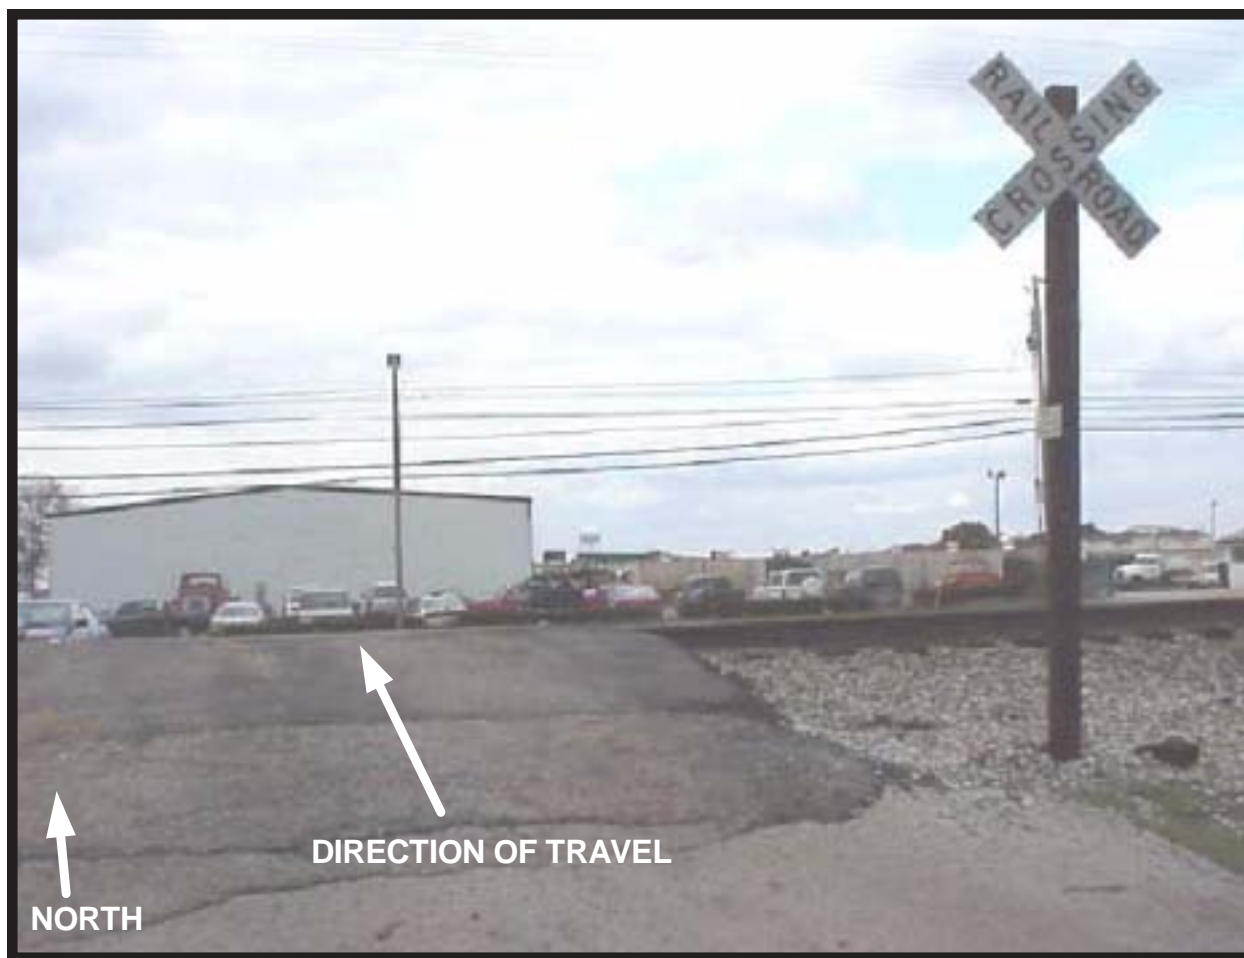
*Photo. Northbound View of Incident.*

**Weather/Road Conditions.** The incident occurred at 2150 hours on a private, unguarded,<sup>b</sup> railroad crossing. The county police estimated that the slope of the private roadway the victim was driving up as he approached the tracks was approximately 17 degrees. The roadway was dry and the weather was clear and cold. A Crossbuck<sup>c</sup> sign was located on the right side of the roadway approaching the tracks (Photo). This is a high-density rail community with 30 trains per day.<sup>d</sup>

The victim departed the training exercise and was traveling north on a private roadway toward a public roadway when he was struck by a freight train as he attempted to traverse a single-track railroad crossing.

<sup>c</sup>A Crossbuck is a type of passive warning device for railroad crossings. It is a white, reflectorized sign with the words RAILROAD CROSSING in black letters (Photo).

***Recommendation #1: Fire departments should ensure that drivers of fire department vehicles come to a complete stop at all unguarded railroad grade crossings during emergency response or nonemergency travel.***<sup>3-4,7</sup>

Discussion: Drivers of fire department vehicles should come to a complete stop at all unguarded railroad grade crossings and assure that it is safe to proceed before crossing the railroad track(s). Additionally, drivers should use caution when approaching and crossing any guarded grade railroad crossing. National Fire Protection (NFPA) 1500, § A-4-2.8 states that vehicle accidents at railroad crossings have
